USDA Forest Service, Tongass National Forest

Margaret-Traitors IRMP

Ketchikan-Misty Fiords Ranger District

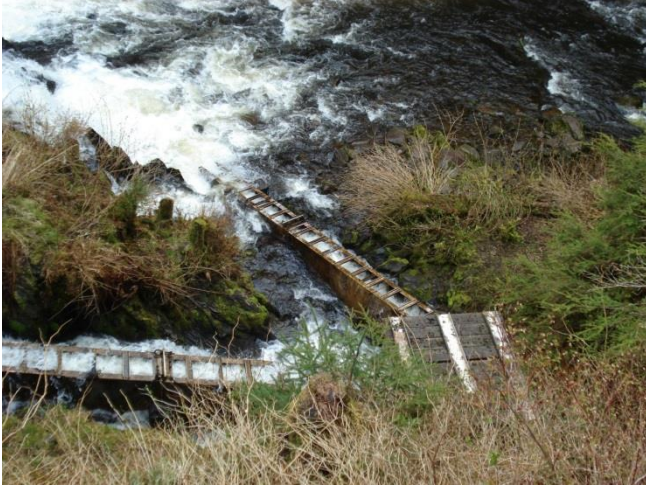
Figure 5. Margaret Fish Ladder

The Margaret Creek Watershed contains coho, sockeye, pink, and chum salmon, as well as resident and anadromous cutthroat & rainbow trout (steelhead), Dolly Varden char, kokanee, sculpin and three spine stickleback. The Margaret Creek Fish Ladder (Fishpass) was constructed below Margaret Lake in 1989 allowing seven species of anadromous fish (pink, sockeye, chum, cutthroat, Dolly Varden, coho and steelhead) access to over five miles of available spawning and rearing habitat above the fishpass (Figure 5).

- Monitor Fishpass at Margaret for annual maintenance. Replace missing baffles and repair trail down to ladder.
- Visit Barrier 2.3km upstream from salt water on Traitors creek for barrier enhancement opportunities.

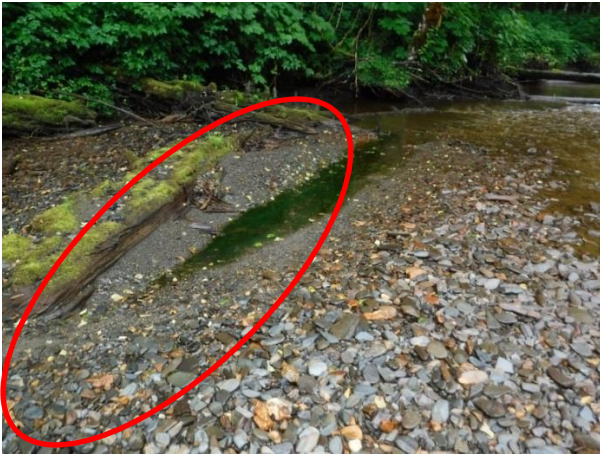
Figure 6. Legacy wood in Margaret Creek

Clear-cut timber harvest occurred in the Margaret Creek Watershed beginning in 1960. Greater than 10 percent of the watershed was harvested on slopes >72 percent. Nearly 24% of the Margaret Creek watershed was harvested with 9% occurring in the last 30 years. Timber harvest also occurred in over 40% of the Riparian Management Area (RMA) of Margaret Creek. The majority of the RMA harvest occurred in floodplain channel types; the most sensitive channel types to management for stream function and valuable fish habitat (see Figures 6 & 7). The harvest of the riparian management areas resulted in a lack of stream bank stability and necessary large wood, both in the channel and for future recruitment.

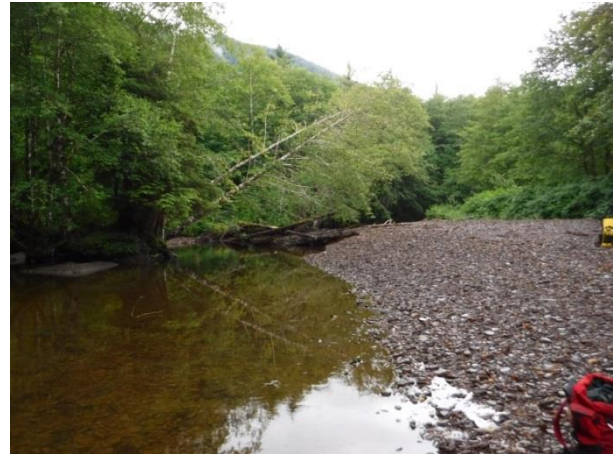
Figure 7. Lack of large wood in Margaret Creek

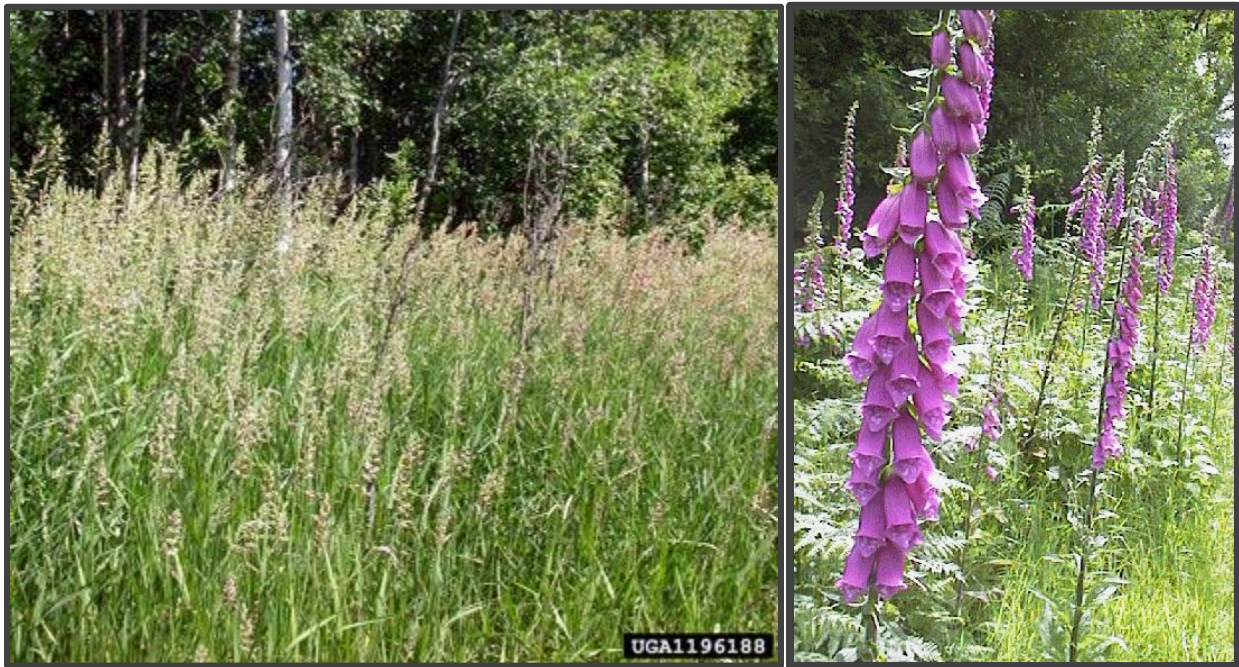
Figure 11. Invasive plants along the road system, showing reed canary grass (Left), and purple foxglove (Right).

Purple foxglove (Figure 11), oxeye daisy, common St. Johnswort, hairy catsear, and reed canary grass (Figure 11) need to be controlled or eradicated at the population source, to prevent further spread along the roads and to other recreation areas on the Ketchikan-Misty Fiords Ranger District.
